Incident Reports

1. Transat Jacques Vabre - Hugo Boss – IMOCA 60- Collision with unidentified object

IMOCA HUGO BOSS TV KEEL GROUNDING REPORT

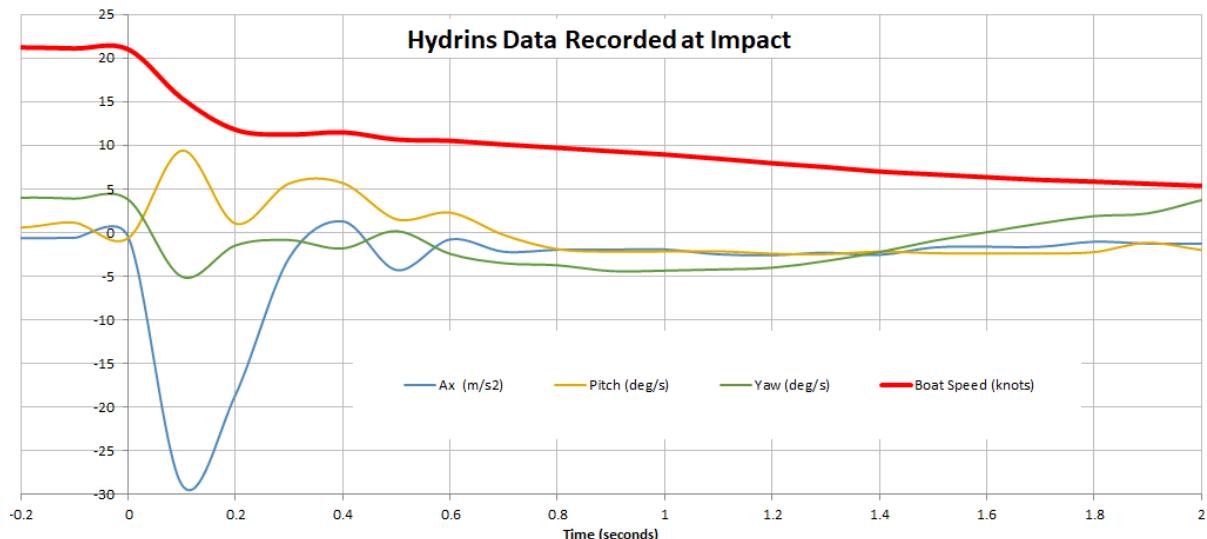
During the incident the on-board Hydrins recorded a maximum negative acceleration of 28.9 m/s^2

The boat's speed dropped from 21.0 to 11.8 knots in period 0.2 seconds; before slowing down to 2 knots over the next 2.7 seconds.

The boat can be seen to pitch bow down and yaw to port as a response to the impact.

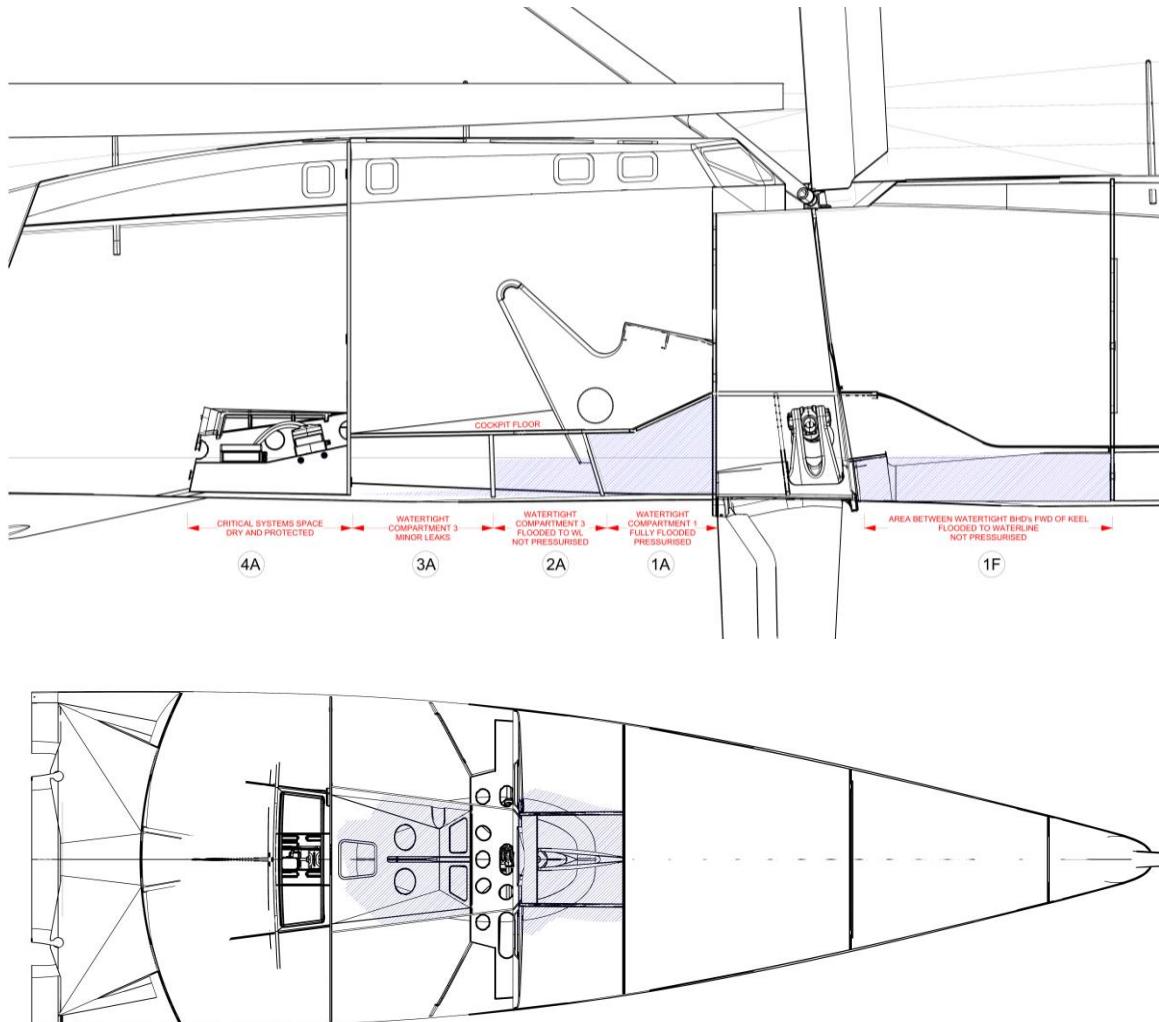
The aft keel bearing is under the forward part of the cockpit. As you can see below there are three watertight compartments under the cockpit which prevented any water getting into the critical systems. This design was to support the cockpit floor not specifically make a water tight box around the keel. Undoubtedly this saved the boat from being abandoned.

- 1 Fwd** Flooded to waterline, but not pressurised. Easily managed and not a concern to skippers. Watertight doors closed at each end of compartment.
- 1 Aft** Fully flooded compartment, pressurised when underway. Contained between cockpit sides and cockpit floor.
- 2 Aft** Flooded to waterline, but not pressurised. Contained between cockpit sides and cockpit floor
- 3 Aft** Minor leaks through penetrations, Contained between cockpit sides and floor.
- 4 Aft** Systems Space – Housing motor, batteries, keel pump and most electrical systems. Completely dry and well protected during incident.

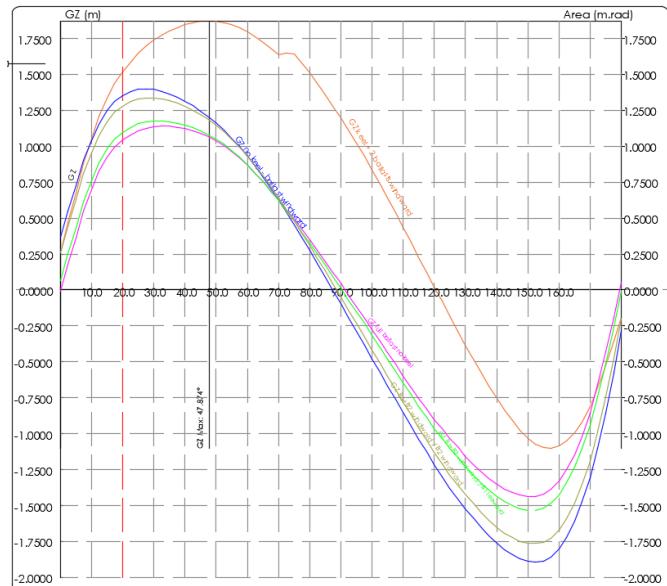
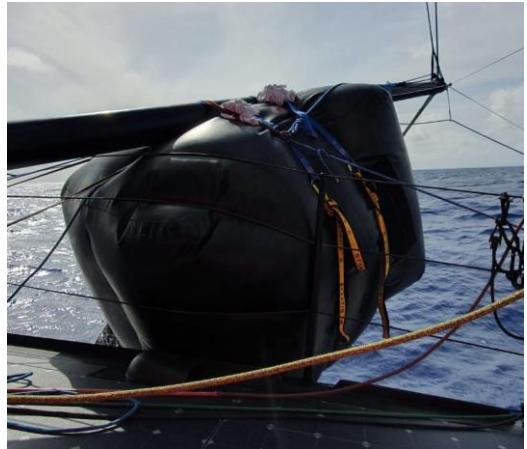
Left: Degraded Stability Curve for Hugo Boss after the incident.
Above: Additional measures for stability using an inflatable fender stored on-board.

The ballast tanks were filled to gain stability but both the mid tanks were damaged at the forward end where they drained into the keel area and were constantly emptying.

The Skippers felt the boat vulnerable to capsize and so inflated a large fender that was secured under the deck spreader to help with any large amounts of heel.

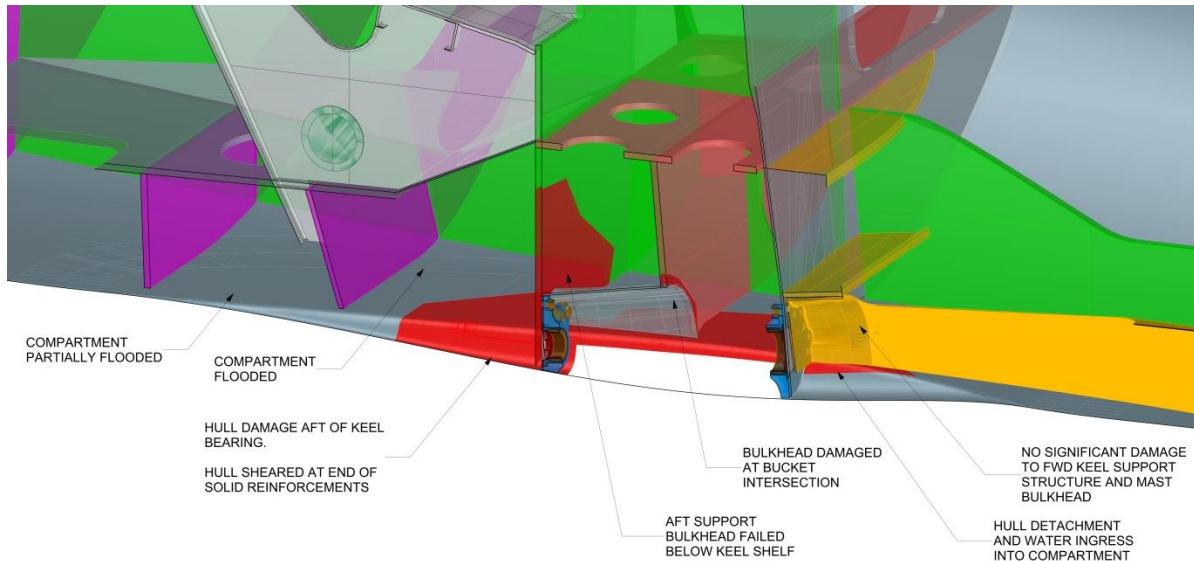
ASSESSMENT OF THE DAMAGE

AFT STRUCTURE FAILURE

Inspection of the damage showed that the aft supporting structure had failed allowing the aft keel bearing to move aft and the keel to then become detached and drop out of the hull.

The aft support bulkhead failed under keel shelf. The aft bulkhead failed mid-panel as a consequence of the rest of the keel support structure failing and moving aft.

The keel bucket (a monolithic moulding over the aft half of the keel) de-bonded from the hull and moved aft with the keel bearing; this prevented the impact force from being shared into the hull skin and connected forward structure.

There was no observable significant damage to the keel bolts or keel bearings. The aft bearing remained attached to the keel bulkhead, bucket, and hull reinforcement assembly and the whole section moved aft, detaching from the surrounding structure as a unit.

There was very little damage to any structure forward of the keel. The mast bulkhead, forward keel bucket and support shelves showed no damage after NDT inspection.

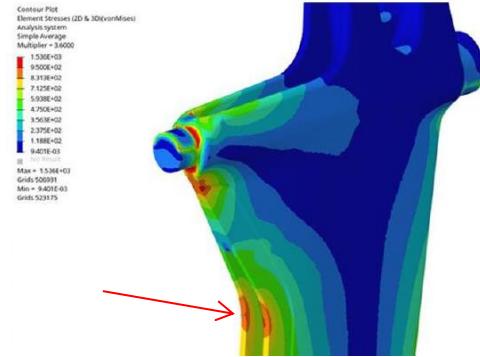
STRUCTURAL HIERARCHY

Composite - ISO Rule lower grounding	3.60g	86%
Keel bearing (Yield)	3.74g	89%
Keel Fin Yield	4.20g	100%
Keel Bearing bolts (ULT)	5.23g	125%
Composite – New Structure Target	6.4g	150%
Keel pin (pure shear)	9.27g	221%

The study showed that in a lower grounding incident the keel fin would begin to yield at a load equivalent 4.2g. This means that an IMOCA designed to the current ISO rule would have the composite fail before the keel fin.

In conference with Gurit the team decided it was reasonable *and achievable* to define a new lower grounding case for the composite that exceeds 150% of the yield strength of the keel.

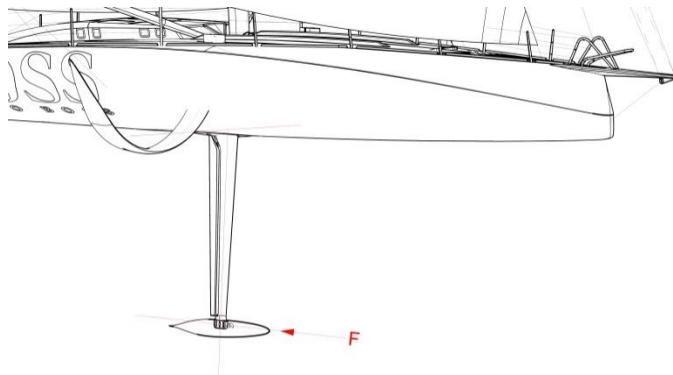
LOWER GROUNDING CASE

ISO Load Case: 289Kn (3.6g)

Increased Load Case: 506Kn (6.4g)

Applied to the bulb with the keel on centreline.

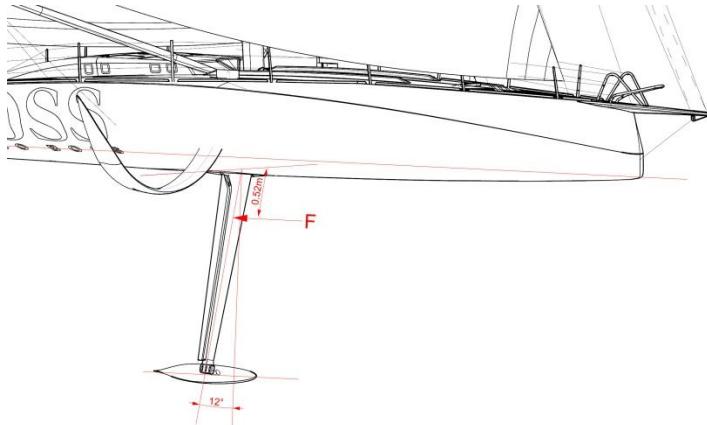
UPPER GROUNDING CASE

No ISO Design Equivalent

New Load Case: 1000kN

Applied at – 0.52m below keel axis and 12 degrees of keel cant.

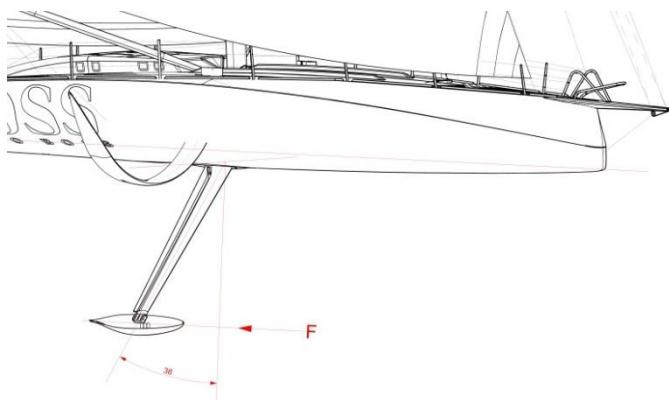
MAXIMUM CANT GROUNDING

Original Structure Ultimate Load: 2.5g

Increased Load: 318kN (3.56g)

The new structure designed to sustain the upper and lower grounding cases was tested against the maximum cant case and shown to be able to maintain 318kN (3.56g); an increase of 42%.

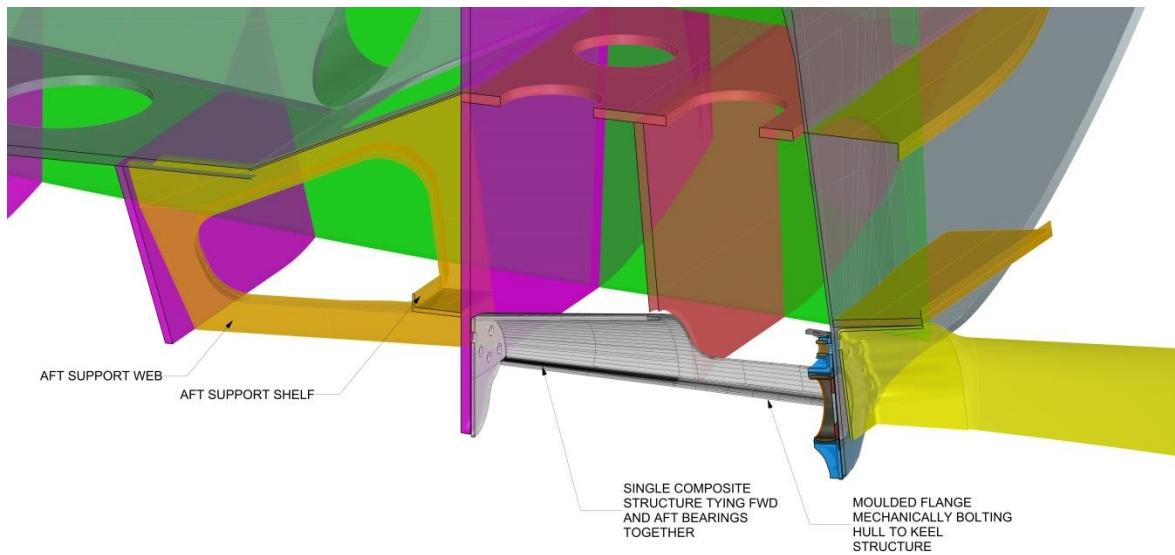
NEW KEEL STRUCTURE ARRANGEMENT

It was observed that the hull failed aft of the c-plate assembly. These c-plates were increased in length and size to dissipate the load more efficiently into the hull skin.

SINGLE COMPOSITE STRUCTURE TYING KEEL BEARINGS TOGETHER

To prevent the keel bearings being able to separate a single monolithic bucket moulding has been designed that wraps and encapsulates both bearings. This moulding is mechanically bolted to the hull skin using the keel fairing bolts to add additional redundancy to the bonding.

AFT STRUCTURE SUPPORT WEBS

To better support the aft keel bulkhead new support structure has been added aft of the bulkhead. These webs dissipate the load over a larger hull area.

INCREASED SIZE OF THE AFT HULL C PLATES

To sustain the increased grounding load cases additional laminate plies were added to the mast bulkhead, aft keel bulkhead, cockpit longitudinals and keel shelf.

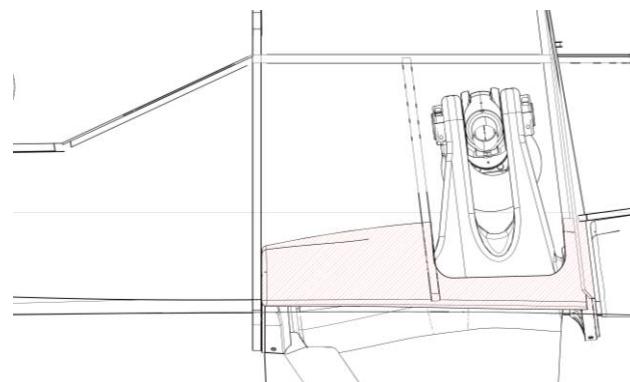
Drawing showing the single monolithic composite moulding wrapping both bearing to prevent separation in a grounding event

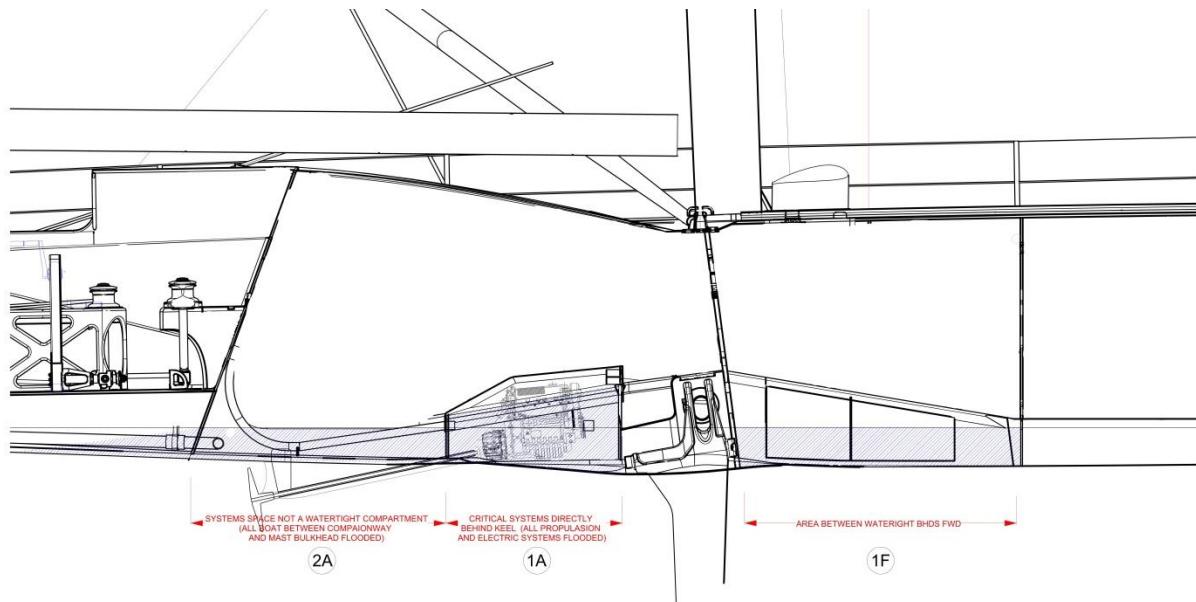
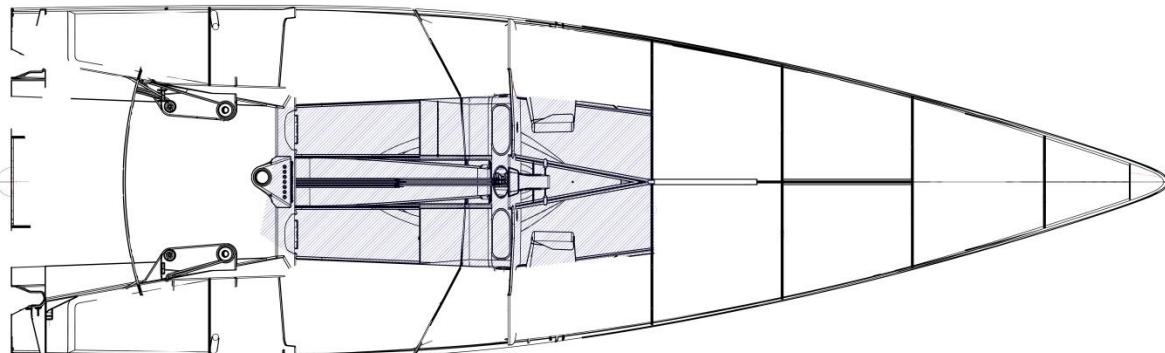
Below is the HB6 layout. The same incident on this boat would have flooded the main compartment including the electronics, engine and batteries. **Almost certainly we would have abandoned the boat. Most IMOCA 60's have a similar layout to HB6.**

1 Fwd Floored to waterline, but not pressurised.

1 Aft Systems space, all electronics and engine fully flooded and pressurised when under way.

2 Aft Water from systems space will flood over ring frame under pressure and flood cabin

ATR strongly recommend that the Class make it mandatory for IMOCA's to have a watertight compartment surrounding the aft keel bearing and crash structure to protect the boat and systems from flooding in a grounding incident.
