Carbon Fibre in Pulpits and Stanchions

Public Comment

Final Recommendations

WP Project Managers:
Fred Barrett (Naval Architect)
Glen Stanaway (Yachting Australia)

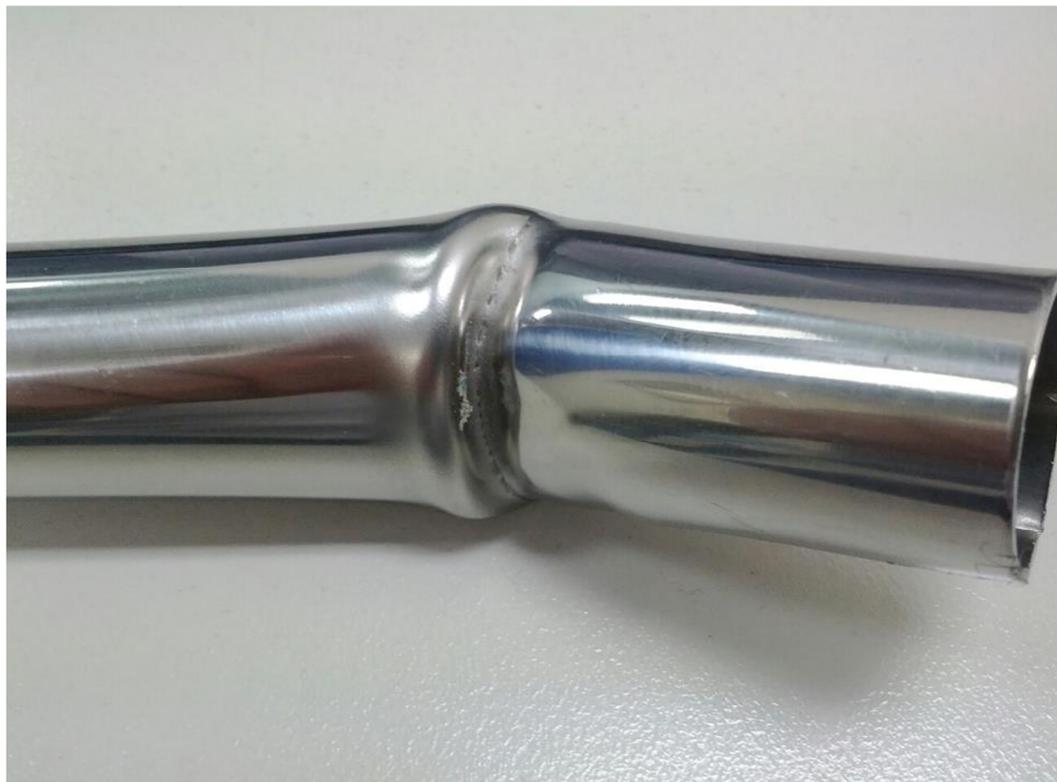
2. Stainless steel #2	The second test shows that the standard production stainless steel stanchion fails at approximately 60kg of lateral load. This is about the same requirement of the ISO 15085; it would have complied. It folds and results in two hard points at the fold. There is evidence of tearing of the stainless steel on the inside of the fold indicating that it is close to breaking off.

Stainless Steel. The tear can be seen in the middle of the fold. Straightening the stanchion risks breaking the stanchion in half.

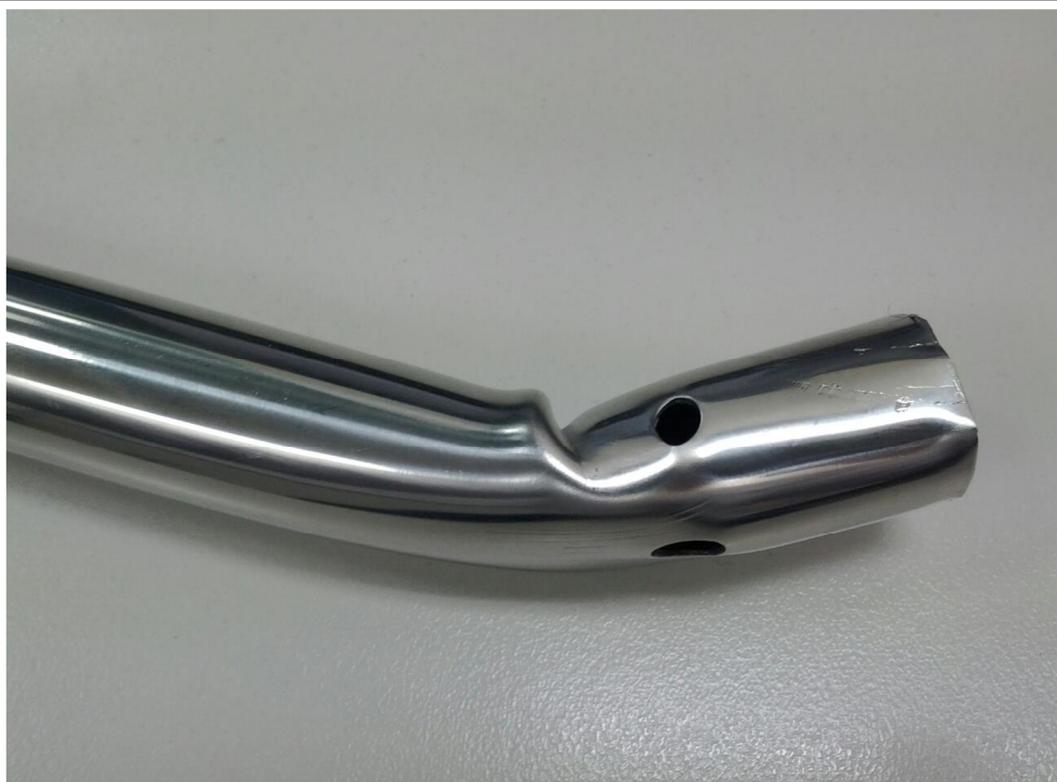
Stainless Steel. The stainless steel has deformed significantly.

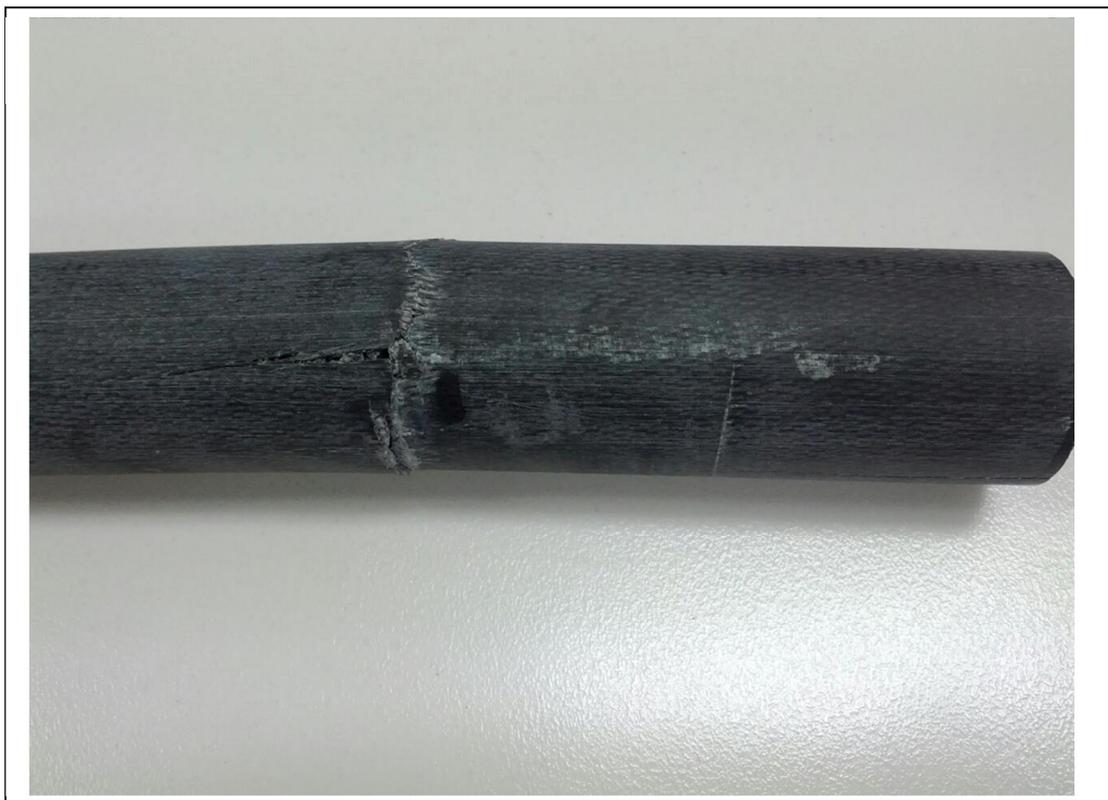
3. E-Glass	The third test shows that the E-glass stanchion breaks at around 205kg of lateral load. A click or ping can be heard as the epoxy and fibres first crack, and a corresponding drop in weight is seen on the load cell as the stanchion 'gives'. It then breaks and completely fails under the load. The broken stanchion did not separate completely in the test, but the stanchion does show signs that if separated there would be rough tearing. It is theorised that the E-glass stanchion has the greatest breaking strength as it has the greatest elasticity. The E-glass stanchion is 2mm (8 wraps) of unidirectional glass wrapped first. Approx. 2mm (8 wraps) of standard GEP 224 glass is added. Then a further 1mm (4 wraps) of GEP 224 is added for about 580mm along the butt. The standard glass is a "satin weave" pattern. The fibres are interwoven in such a way to lock it all together. The fibres run similar to 75% longitudinal and 25% latitudinal.

E-glass. Rough tears can be seen where the break has occurred. This is evident on the full circumference of the stanchion.

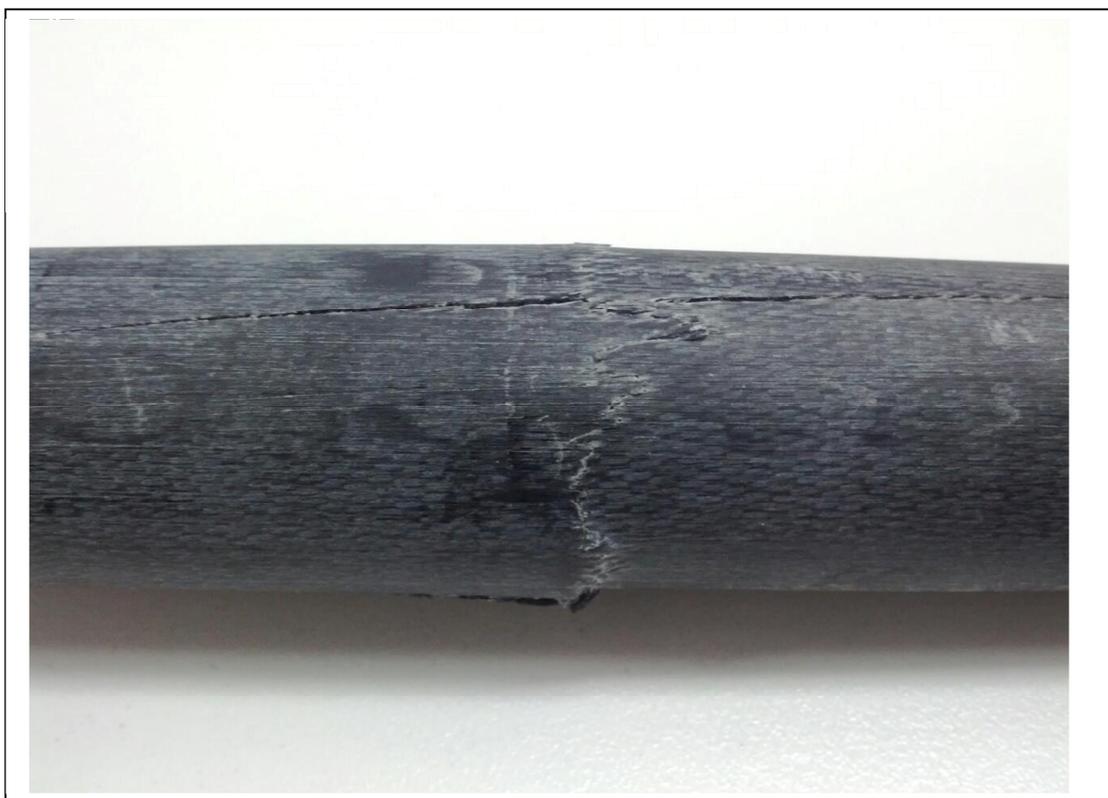
E-glass. Closer viewing shows velar vertical splits in the E-glass.

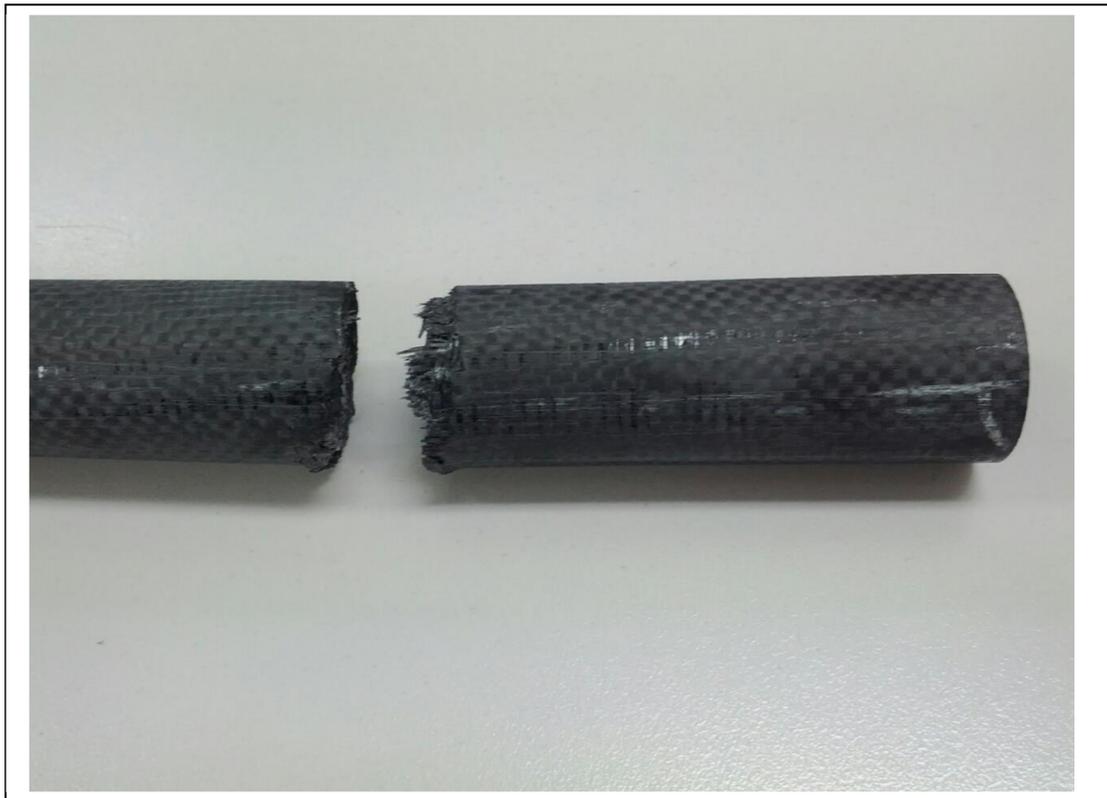
4. Carbon fibre	The fourth test is the carbon fibre stanchion. At around 178kg of lateral load a click or ping can be heard as the epoxy and fibres first crack, and a corresponding drop in load is seen on the load cell as the stanchion 'gives'. It then breaks off at around 168kg of load. The broken stanchion shows rough tears, but no 'razor sharp' shards or edges. The carbon fibre stanchion was made identically to the E-glass model. It was GEP224 on the inside, with a woven carbon similar to the GEP224 pattern on the outside. The build-up at the base was woven carbon.

Carbon fibre/E-glass. Rough tears can be seen where the break has occurred. This is evident on the full circumference of the stanchion.

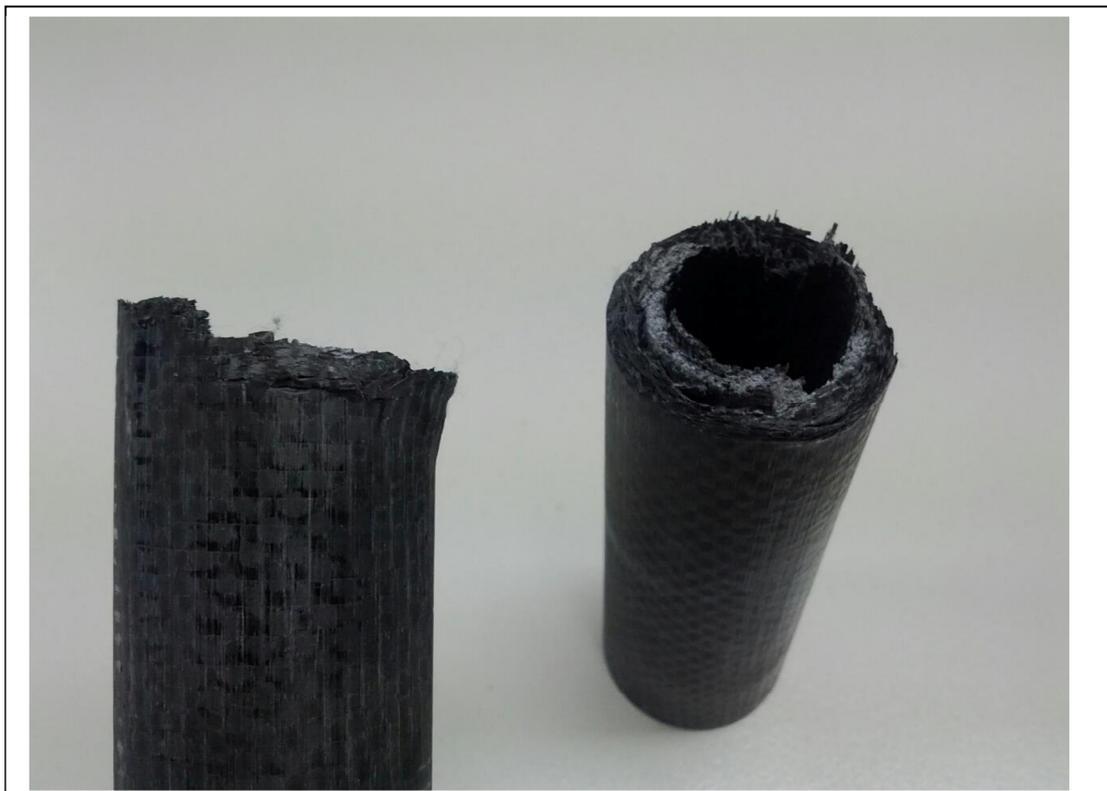
Carbon fibre/E-glass. Closer inspection shows the rough edges.
