Chairman's Report – Yacht Design Developments

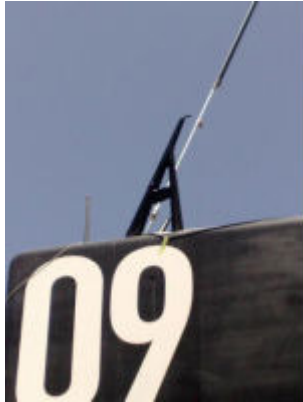
Stanchion / Pulpit

The box rule classes seem to be producing boats with undesirable trends in pulpit design. Team New Zealand's latest TP 52 had what was effectively a stanchion as its pulpit. And a number of boats are now fitted with glass fibre stanchions, pulpit and pushpits which to all effects have the inherent problems of the prohibited carbon fibre stanchions.

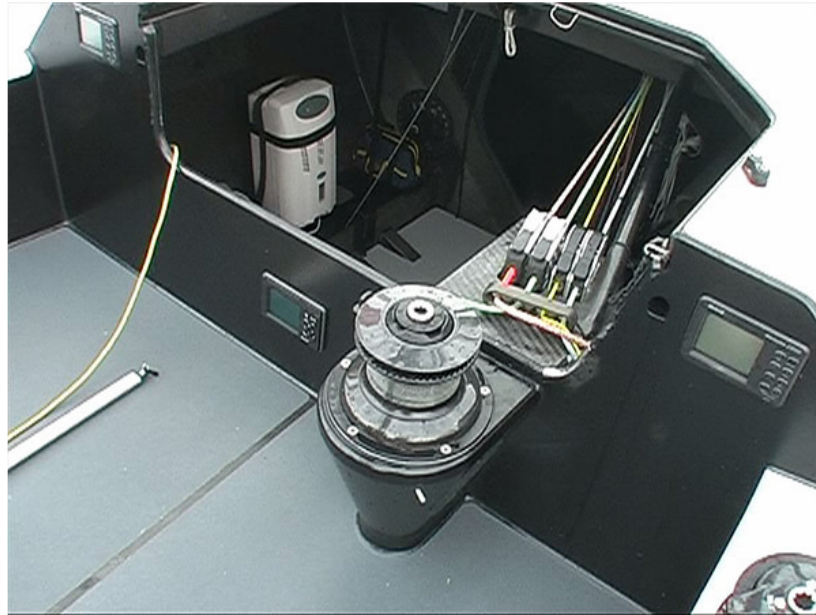
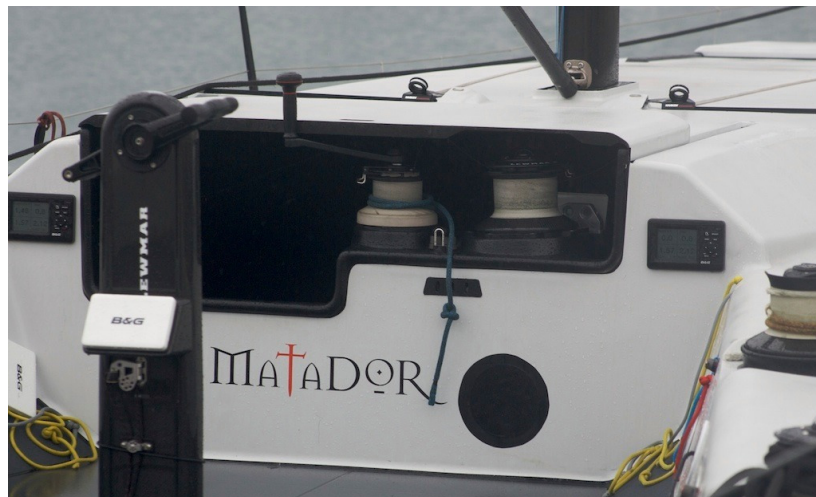
Companionway - Excessive Size

The latest trend in raceboat design is to run all the halyards and control lines through the interior of the boat. The reasons include simplification of deck layout, reduction of structural loads on the coachroof and windage. However the solutions both lead to compromised interiors, overly large companionways and issues related to the use of the onboard systems while the boat is in a watertight configuration with the washboards and hatches shut. This may present issues with stability when a large cockpit is flooded. Below are two pictures of 2009 generation TP52 showing the arrangement.

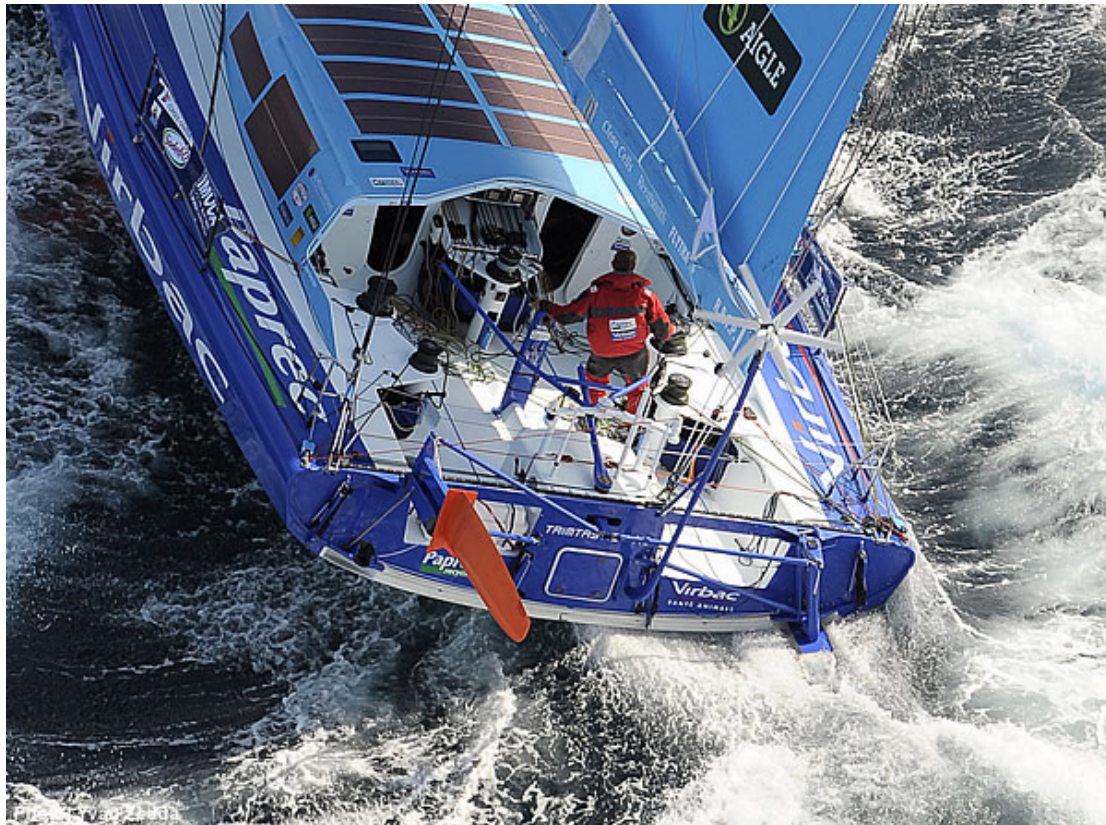
Twin Companionways

Twin companionways are becoming an increasingly common design trend, particularly amongst the offshore short handed classes like the Class 40 and Open 60. The obvious issue is that this arrangement pushes the companionway out towards the sheerline, decreasing downflooding angle and increasing potential water ingress in a knockdown situation.

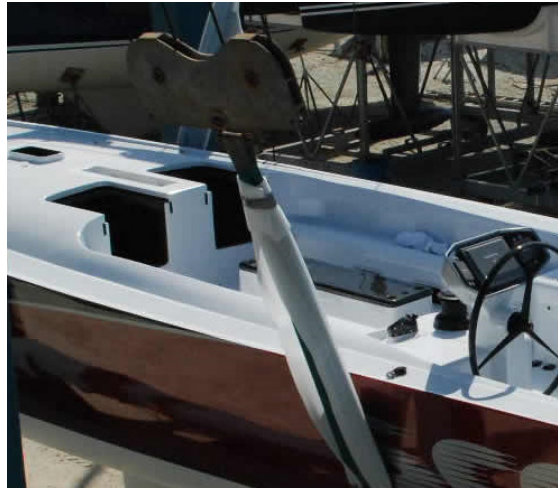
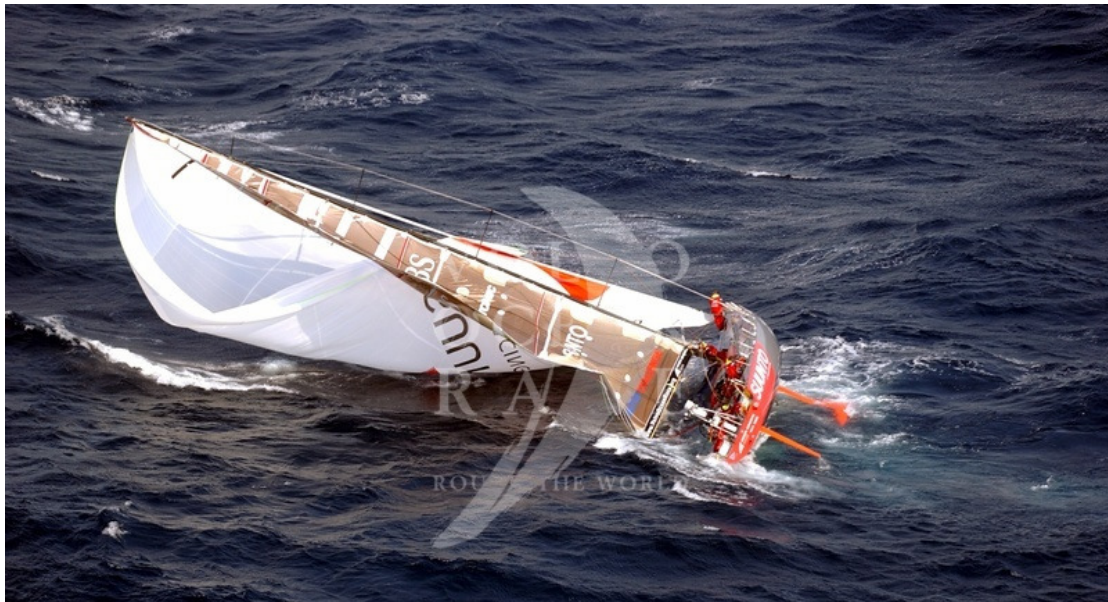
While these arrangements in the open classes with such significant beam may not be so critical, as the static waterline is still likely to be well below the companionway openings, even at ninety degrees knockdown. Below is a picture of a Volvo 60 suffering a knockdown.

It has started to appear on other boats namely SEB Volvo 60 and the Bull 7000 Sportsboat. The reality of a knockdown is that in a dynamic situation, particularly on narrower beam boats, substantial water ingress is likely.

A centre companionway is almost always achievable and it appears this trend has been led by the simplification in deck design layout. The question for the committee is should the OSR remain non-typeforming unless it specifically affects safety? Is this development something the committee want to get involved in before it becomes a common arrangement?
