OSR WORKING PARTY REPORTS

Lifeline Material Working Party

Title: ISAF OSR Lifelines 140919

Date: 19th September 2014

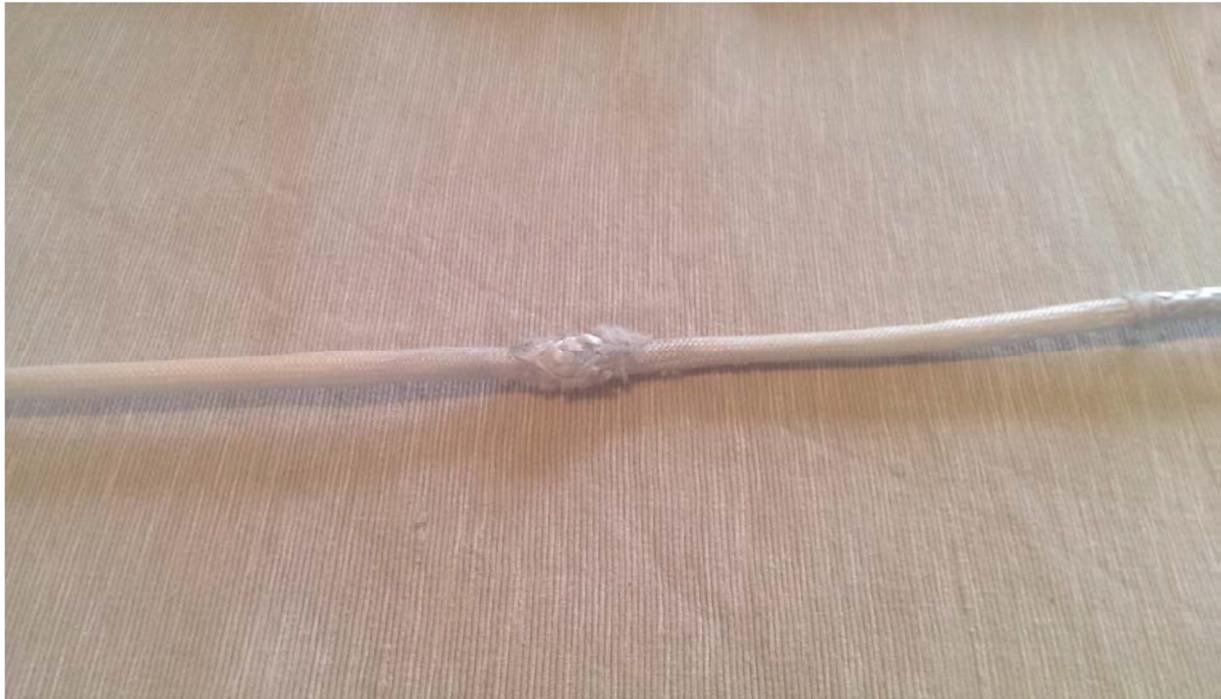
Example of Dyneema® lifeline chafe

It has also been noted that wear from running rigging chafing on the lifelines at speed can wear HMPE very rapidly. One example given was a 100 foot racer/cruiser that had brand new Dyneema® lifelines, being used for the first day. Whilst performing a gybe during training, allowing the asymmetric spinnaker sheets to run from the turning block, hard against the top lifeline, as was normally done with the stainless wire lifelines, the Dyneema® lifeline failed on the first gybe, having been cut through by the PBO braided cover of the sheet moving over it at speed.
